Influence of ECO coating thickness and microstructural defects on corrosion, corrosion fatigue, and stress corrosion cracking in biomedical Mg alloys

Coating technology
Corrosion fatigue
Biomedical application
Corrosion mechanisms
Stress corrosion cracking

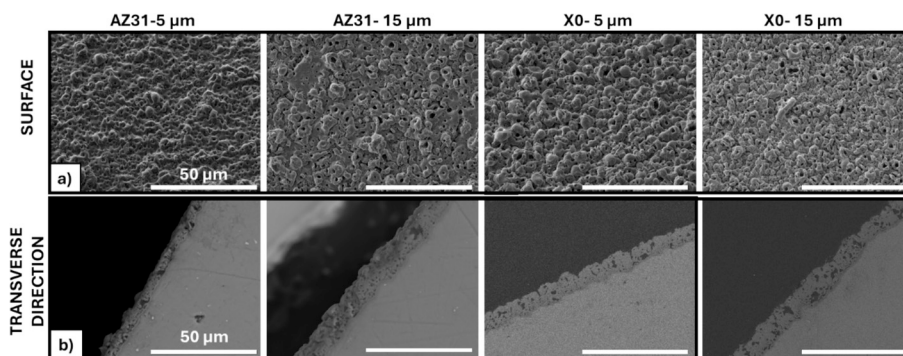
Surface and cross-sectional SEM images of ECO-coated AZ31 and X0 specimens with nominal thicknesses of 5 μm and 15 μm are shown in Fig. 2. The 5 μm coatings exhibited a comparatively smoother and more uniform surface, whereas the 15 μm coatings displayed a rougher and uneven morphology, and this is in agreement with our previous work [29]. The pores in the 15 μm coatings appeared larger than those in the 5 μm coatings [30]. Surface images highlighted open pores, each surrounded by a rim of coating material. Cross-sectional views confirmed that surface pores and cracks extended through the porous outer region of the coating down to a thin dense interfacial layer of approximately 1 μm (Fluoride-rich) adjacent to the substrate. The ECO process eroded the alloys, but this dense coating layer was continuous across the undulating alloy surface, and no evidence of delamination or loss of adhesion was observed.

Fig. 2. Surface and cross-sectional SEM images of ECO-coated AZ31 and X0 specimens with nominal coating thicknesses of 5 μm and 15 μm . (a) SE surface images. (b) Cross-sectional BSE-SEM images. Scale bars are 50 μm in all panels.

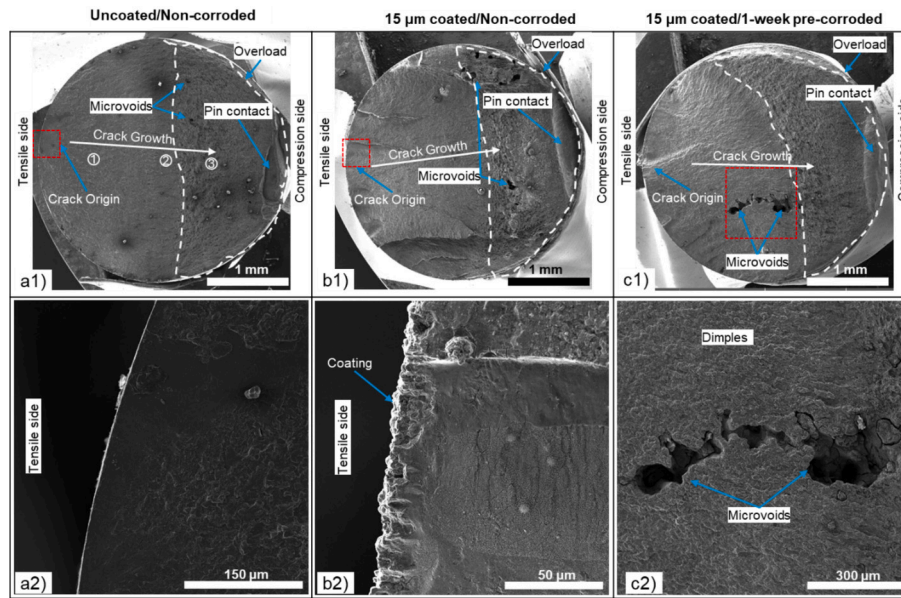
Fracture surfaces from all AZ31 conditions showed initiation of cracks on the tensile surface and crack growth from the tensile side toward the compressive (loading-pin) side (Fig. 7a1–c1). In each case, a small, comparatively smooth initiation zone was observed at the tensile edge, followed by a rapid transition to a dimpled morphology associated with final overload. In all the specimens, the origin surface at the tensile edge was smooth; whereas in fracture specimen, shallow surface

imperfections/pits coincided with the initiation site. In the 15 μm coated specimens, no interfacial delamination was evident at the origin. The 15 μm coated AZ31 samples that were pre-corroded in HBSS for 1 week (Fig. 7c1–c2) displayed abundant microvoids. No evidence of classical concentric fatigue striations was observed on any fracture surface.

Fig. 7. Fatigue fracture surfaces and initiation morphologies of AZ31 rods tested 3 PB. Top row (a1–c1): whole-section views with the tensile side on the left and the loading-pin (compressive) side on the right; the neutral axis is indicated by a dashed line and the peripheral final overload (shear-lip) rim is outlined. (a1) Uncoated, non-corroded, (b1) 15 μm ECO, non-corroded, and (c1) 15 μm ECO, 1-week pre-corroded in HBSS. Bottom row (a2–c2): corresponding high-magnification details (a2) tensile-edge origin area in uncoated non-corroded, (b2) crack initiation of 15 μm coating and non-corroded, and (c2) microvoid coalescence representative of the final-overload region. 1–2–3 in a1 refer to the regions investigated at high resolution in Fig. S 2.

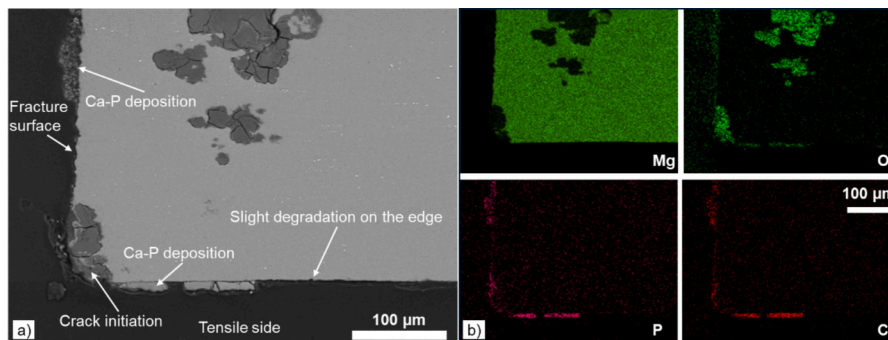
BSE/EDS analysis of an AZ31 cross-section taken at the tensile side after 3 PB fatigue in HBSS shows local by Ca–P deposits over the surface (Fig. 8). The crack-origin lies at the tensile edge adjacent to these deposits and there is no evidence of a continuous Mg-oxide/hydroxide

Fig. 8. BSE cross-section and EDS elemental maps in the tensile region of AZ31 specimen after 3 PB fatigue in HBSS. (a) BSE image of the tensile-edge region. (b) EDS maps of the same field of view for Mg, O, P, and Ca.

scale; instead, the chemistry is dominated by apatite-like Ca–P precipitation. In the BSE image (Fig. 8a) bright plate-like islands are on the surface and correspond to regions where Ca and P are co-localised as shown in EDS maps, while the Mg is absent in these regions (Fig. 8b). Also, the dark peripheral band is oxygen rich and is consistent with embedding resin that has infiltrated the edge rather than with $\text{Mg}(\text{OH})_2/\text{MgO}$. The metallic matrix exhibits a uniform Mg map, indicating no pervasive subsurface degradation.

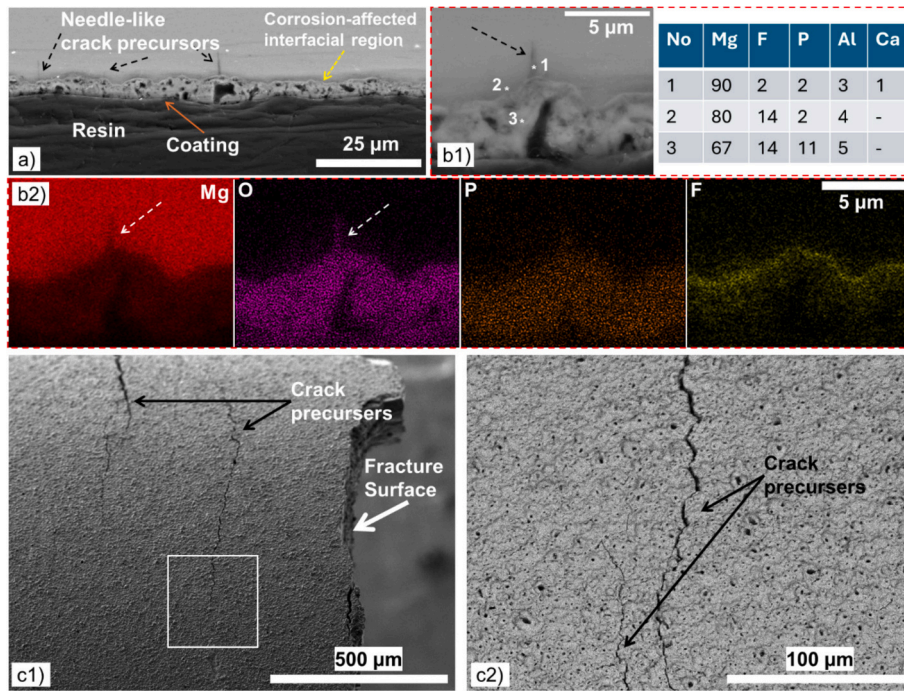
Surface and cross-sectional analyses reveal the local damage that precedes fatigue failure (Fig. 9). A 5 μm ECO-coated, non-corroded intact AZ31 rod was taken off test at 25,000 cycles prior to final fracture, mounted, sectioned, and polished. SEM of the tensile-side region close to the loading pin revealed regular, needle-like crack precursors located within the coating and immediately beneath it in the substrate (Fig. 9a). EDS maps showed these features to be oxygen-enriched with trace Ca (≈ 1 wt%) (Fig. 9b1–b2). Along the coating–substrate interface, a corrosion-affected interfacial region was evident (Fig. 9a), where the Mg signal was reduced relative to the adjacent matrix; notably, no continuous interfacial delamination was observed.

In a separate specimen with a 15 μm coating, fracture occurred after 59,000 cycles, and the tensile surface showed similar needle-like crack

Fig. 9. Needle-like crack precursors revealed by cross-sectional SEM/EDS and tensile-surface imaging. (a) Cross-section from a 5 μm ECO-coated, non-corroded AZ31 rod interrupted at 25,000 cycles (tensile side near the loading pin). (b1) High-magnification view of one precursor and representative EDS point analyses (wt%) at locations 1–3. (b2) Elemental maps (Mg, O, P, F) across the precursor. (c1) Tensile surface of a 15 μm-coated specimen that fractured at 59,000 cycles; the boxed area is enlarged in (c2).

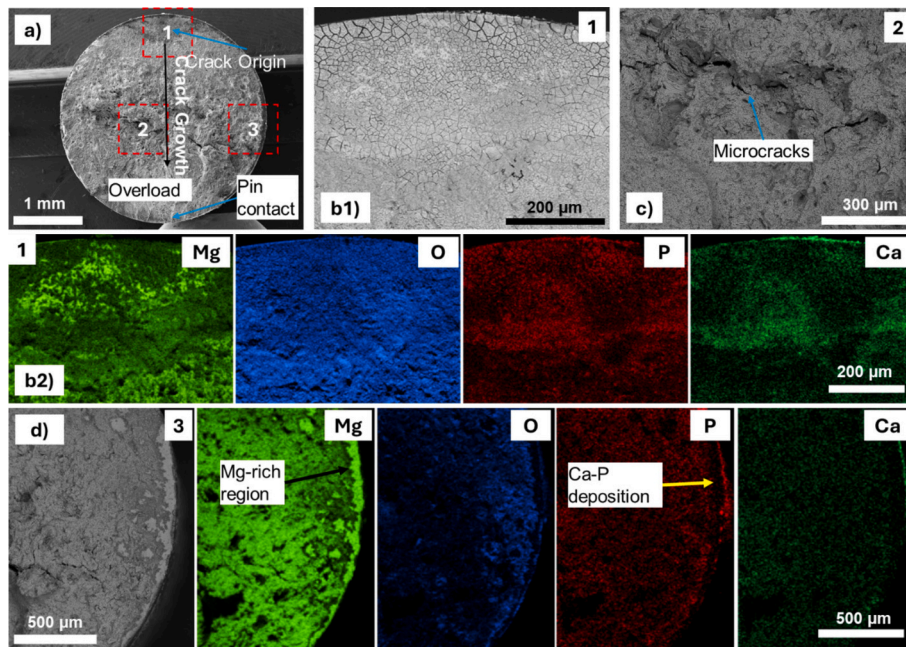
Fig. 10 shows the fracture surface and chemistry of a X0 Mg alloy immersed in HBSS for 1 week before the test. After failure in 3 PB, the whole-section view shows a tensile-side crack origin with growth toward the compression side, bounded peripherally by a shear-lip (overload) rim; the pin-contact imprint is evident (Fig. 10a). In Area 1 near the tensile edge, the fracture surface is covered by speckled deposits; EDS maps reveal O–P–Ca enrichment with local Mg depletion, consistent with Ca–P deposition on the surface (Fig. 10b1–b2). In Area 2, located close to the neutral axis, the fracture surface contains microcrack arrays that run across the field and locally intersect the main crack (Fig. 10c). Area 3, taken at the edge near the neutral axis, exhibits a composition gradient: the interior appears Mg-rich, while the outer rim shows Ca–P enrichment on the fracture surface (Fig. 10d).

Fig. 10. Fracture surface and chemistry of uncoated X0 after 1 week of pre-corrosion and subsequent 3 PB fatigue failure. (a) Whole fracture section showing the crack origin, crack-growth direction, final-overload region, and pin-contact zone; red dashed boxes indicate Areas 1–3. (b1) Higher-magnification view of Area 1. (b2) Corresponding EDS maps (Mg, O, P, and Ca). (c) Area 2 near the neutral axis. (d) Area 3 near the edge close to the neutral axis, with corresponding EDS maps.

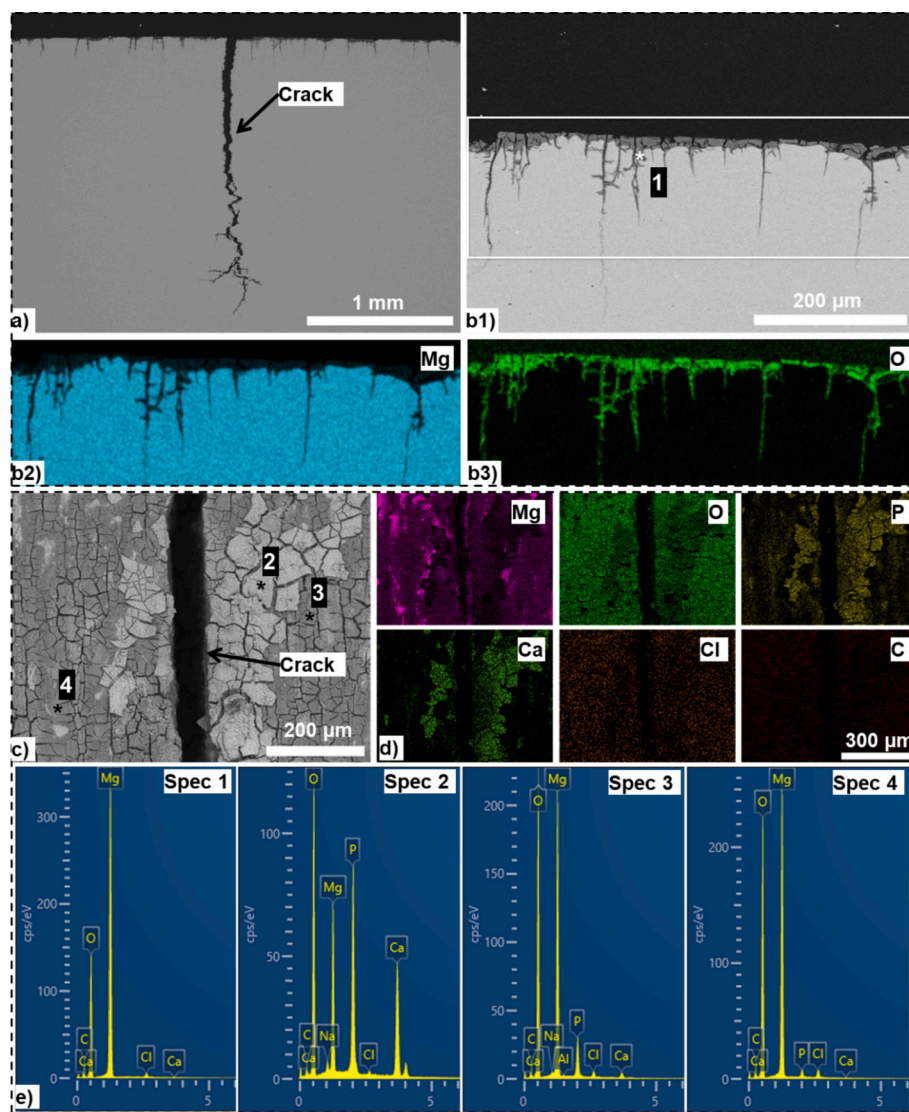
X0 alloy specimens without coating and without immersion in HBSS did not fracture within the prescribed life. A cross-section prepared from a specimen interrupted at 127,000 cycles revealed a dominant crack initiation at the tensile edge advancing toward the compression side with branching at the tip (Fig. 11a). In the tensile region just below the

surface, numerous needle-like crack precursors were present (Fig. 11b1). EDS maps showed the precursors and the main crack to be oxygen-rich with a corresponding decrease in Mg signal along the same paths (Fig. 11b2–b3).

Fig. 11. Cross-sectional SEM/EDS analysis of uncoated, non-pre-corroded X0 after three-point bending fatigue. (a) Low-magnification cross-section. (b1) Higher-magnification view of the tensile-side region. (b2–b3) Corresponding EDS maps. (c) BSE image of the surface showing the main crack and adjacent deposits; numbered spectrums (specs1–4) indicate the locations of point analyses. (d) Elemental maps (Mg, O, P, Ca, Cl, and C). (e) Representative EDS spectra acquired from the marked locations.

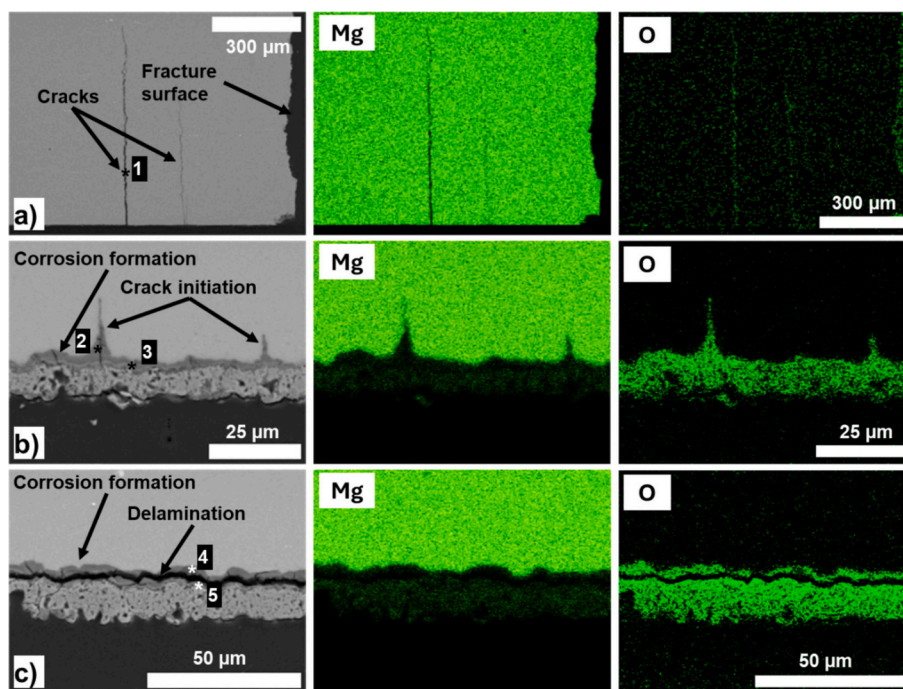
To document fatigue damage, three tensile-side cross-sections were prepared and polished nearly to mid-thickness (~1.5 mm removal) from: (a) an uncoated X0 specimen examined after failure, (b) a 5 μm

ECO-coated specimen interrupted before fracture, and (c) a 15 μm ECO-coated specimen interrupted before fracture (Fig. 12). In the uncoated sample (Fig. 12a), two secondary cracks are visible adjacent to the main fracture surface; both initiate from the tensile surface and extend toward the neutral axis. The accompanying EDS maps and spectrum analysis show a strong O signal along the crack walls and near the free surface, while the Mg signal is depleted only within the crack paths (Table 3-

Point 1). In the 5 μm -coated sample (Fig. 12b), multiple needle-like crack precursors emerge from the tensile surface. A corrosion-affected zone is present immediately beneath the coating and at the coating/substrate interface with O enrichment associated with the intrusions and the interfacial band (Table 3-Point 2 and 3). Point 2, acquired from the corrosion-affected alloy region, exhibits elevated Mg and O contents, whereas Point 3 was acquired on the ECO coating and shows the presence of P, F, and Ca together with lower Mg and O. In the 15 μm -coated sample (Fig. 12c), local delamination is observed within/along the coating near the tensile edge together with an O-rich product layer at the outer surface. The separation is localised and was recorded at a position away from the pin-contact region. Point 4 corresponds to the underlying alloy, whereas Point 5 corresponds to the coating region associated with the delamination feature.

Fig. 12. Tensile-side cross-sections after three-point bending testing with corresponding EDS maps. Left column: BSE-SEM; middle column: Mg map; right column: O map. (a) Uncoated X0 examined after failure. (b) 5 μm ECO-coated specimen interrupted before fracture. (c) 15 μm ECO-coated specimen interrupted before fracture. Numbered points (1–5) indicate locations selected for EDS point analysis; quantitative results are given in Table 3. Scale bars: (a) 300 μm , (b) 25 μm , and (c) 50 μm .

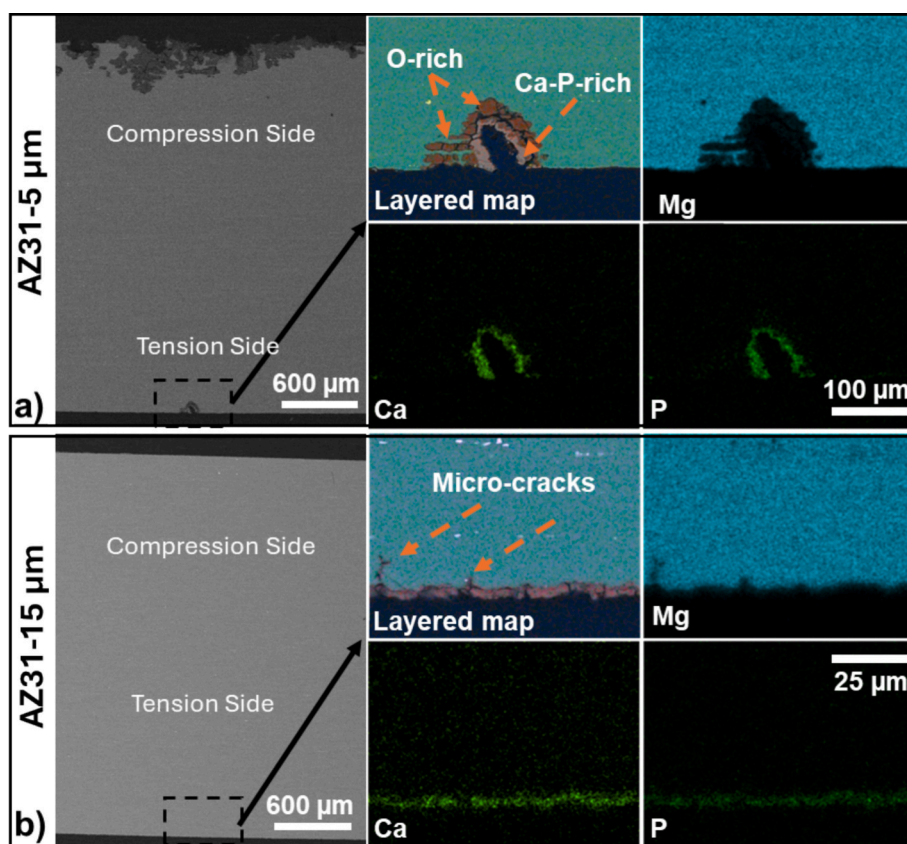
Under static loading at 50 N (elastic region), the uncoated sample exhibited crack initiation from a single point, followed by propagation, indicating the presence of a deep crack origin. Within this region at the surface, oxidized areas as well as Ca–P enriched deposits were detected.

In contrast, in the 15 μm coated sample, crack initiation was less severe, appearing as a number of fine micro-cracks. On this side there was a uniform layer of Ca–P and less evidence of deep pitting that was seen on the uncoated sample. A reduction in coating thickness was also observed at the tensile side, suggesting localised degradation under loading. The compression side was not examined in detail, since pitting effects are likely to cause extensive corrosion and deformation in that region.

Fig. 13. Cross-sectional SEM images and corresponding EDS elemental maps of the tensile and compression sides of AZ31 specimens under static loading in the elastic regime. (a) Uncoated specimen. (b) 15 μm ECO-coated specimen. The maps show the elemental distributions in the regions of interest on the tensile and compression sides.

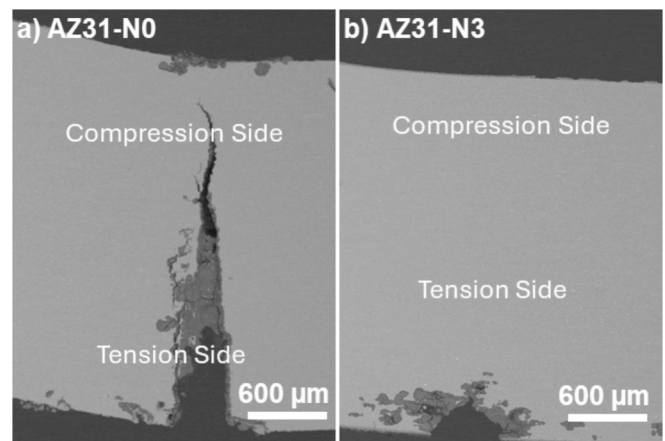
Under static loading in the plastic regime after 2 weeks, the uncoated AZ31 (N0) sample showed a major crack initiated at the tensile side that propagated toward the compression side. This was accompanied by localised material degradation and cavity formation. In the 15 μm coated AZ31 (N3) sample, only small cavities were observed at the tensile side, and no crack propagation across to the compression side was detected.

In the plastic regime (150 N) after two weeks in HBSS, a clear divergence emerged between coated and uncoated specimens. The uncoated AZ31 rods displayed major crack propagation from the tensile to the compressive side, with stepwise load drops (~70–80% reduction) reflecting catastrophic SCC growth across the section (Fig. 14a). In contrast, the 15 μm coated specimens retained a higher residual load (~25% reduction over 14 days) and showed only small cavities confined to the tensile edge, without through-thickness propagation (Fig. 14b). These observations emphasise that the coating, despite its inherent porosity and micro-cracks, was able to delay or suppress catastrophic SCC propagation.

Fig. 14. Cross-sectional SEM images of AZ31 specimens after 2 weeks of exposure under plastic loading: (a) AZ31-N0 and (b) AZ31-N3.
