CASE REPORT

Magnet dislocation during 3 T magnetic resonance imaging in a pediatric case with cochlear implant[☆]

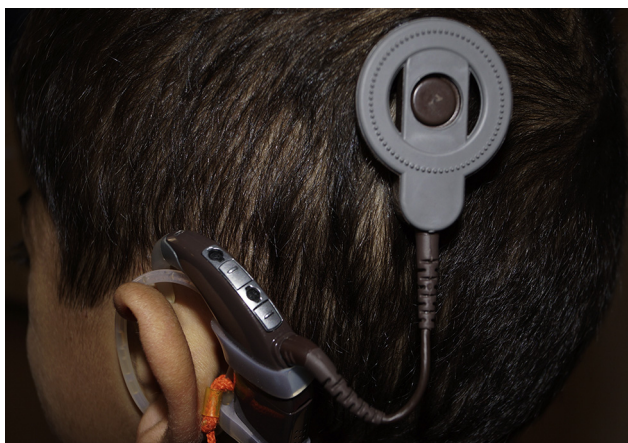
Figure 1 After the reversal of the external magnet, the external part appears to hold on to the internal part.

The physical examination showed a swelling in the area where the magnet was estimated to be located. The magnet had turned upside down, the external part was reversed (inside facing out) and still attracting to the internal part (Fig. 1). After reversing the external magnet, it was attached to the internal part. In this case, it was found that the stimulation had been restored. The patient was examined radiographically and a minimal shift was observed in the position of the magnet (Fig. 2). Considering the status of patient's disease, a new MRI was planned after removing the magnet.

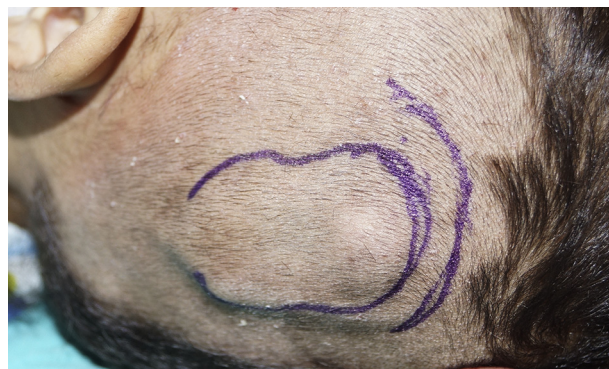
Figure 3 Marking the boundaries of the inner part for planning the skin incision.

A skin incision was performed under sedoanalgesia as it would not pass through the skin contact area of the device's external and internal part (Fig. 3). After incising the skin, subcutaneous tissue and periosteal layer, the internal part of magnet was reached (Fig. 4). The magnet was turned upside down and was found set apart from its bed superiorly. The magnet was removed and the incision was closed. To avoid

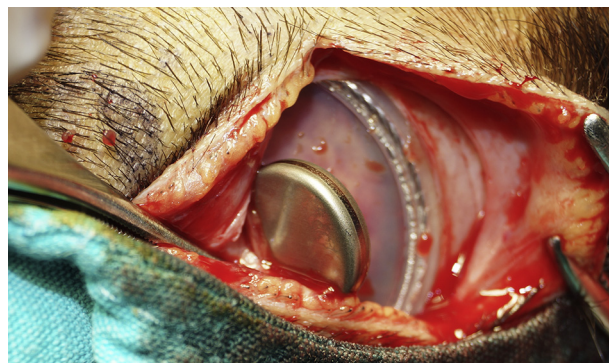
Figure 4 View of the internal part and reversed internal magnet.

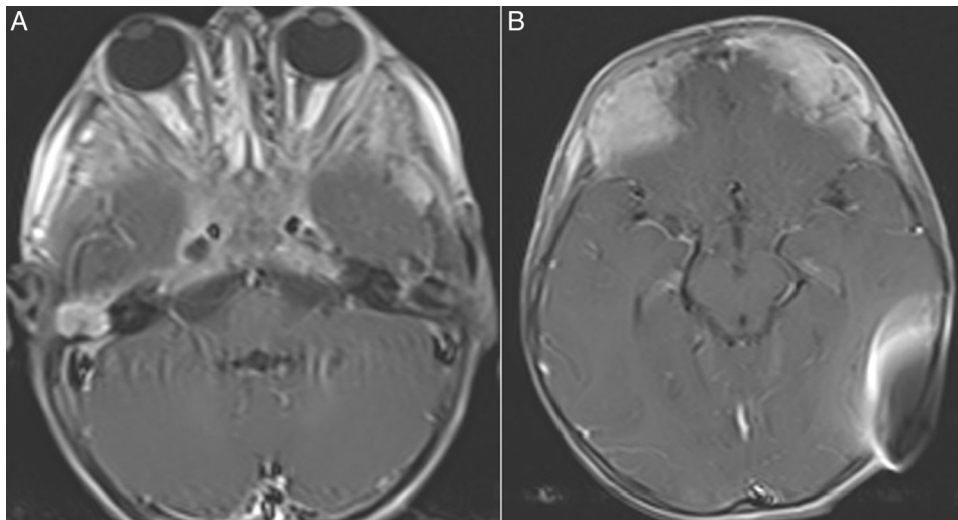
Figure 5 Lesions showing contrast enhancement in the right mastoid bone, skull base and anterior fossa with artifacts created by remainder of the internal part after intravenous contrast medium administration.

hematoma, a compression bandage was applied and then an MRI was performed at 1.5 T. The MRI showed that the tumor had infiltrated the bilateral petrous apex, clivus, cavernous sinus, and the anterior fossa. Additionally, it had obliterated the frontal sinuses and had extended to fronto-parietal calvarial region. The tumor showed diffuse heterogeneous contrast enhancement after intravenous contrast medium administration. Isointense areas in T1 imaging and heterogeneous hypointense areas in T2 imaging were observed (Fig. 5). The MRI procedure was completed without any problems. The patient was recommended a new magnet placement in order to use the implant again, but the parents refused a surgical intervention since the patient was in a bad general condition. They stated that they would decide the intervention after the completion of treatment. The patient currently remains under chemotherapy for treatment of the tumor.
