# Engineering strength through microstructure: gradation and content effects in cemented high-sulfur tailings-crushed rock backfill

High-sulfur tailings  
Crushed rocks  
Particle gradation  
Damage  
Strength gain  
Microstructure

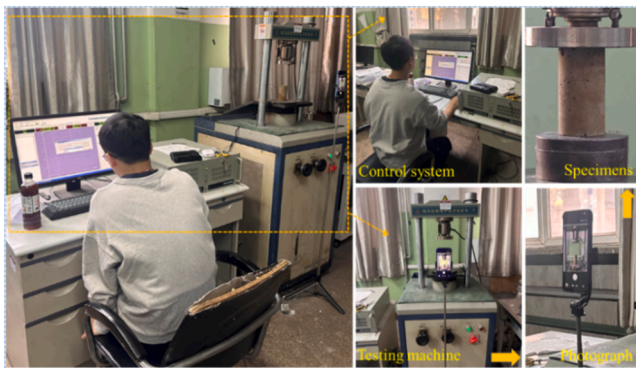
Fig. 6. Photos regarding UCS test's application and evaluation.

Following relevant cures, CHSTCRBs' ends (diameter × height was 50 × 100 mm) were carefully ground flat to ensure uniform load transfer during uniaxial testing. UCS was measured via a computer-precise electronic testing machine at a dislocation proportion of 1 mm/min [32]. Records were nonstop taped and stored digitally throughout test, while a camera documented specimens' failure progression. To minimize experimental variability, 3 filling materials were tried for every recipe, and median strength was assessed. Fig. 6 demonstrates UCS testing procedure.

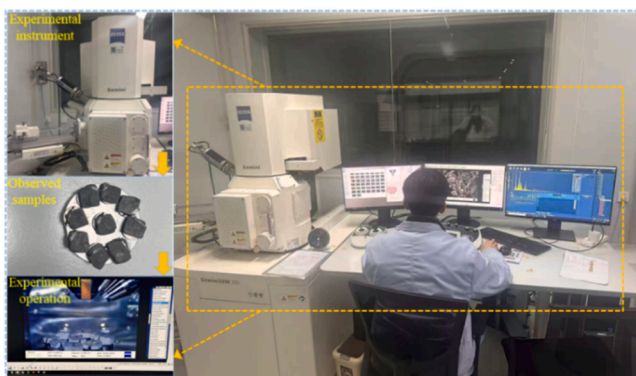
Fig. 7. Creation, curing and testing steps for SEM-EDS specimens.

Fig. 7 illustrates the SEM-EDS characterization procedure adopted in

this study. The microstructure of CHSTCRB was observed via a ZEISS Gemini SEM 300 operating at a hastening voltage of 10–20 kV, an enlargement of 3000 $\times$ , and a running space of 8–9 mm. Prior to observation, specimens were dried at 50  $^{\circ}$ C, sputter-coated with platinum to enhance electrical conductivity, and analyzed under vacuum conditions. Integrated EDS and BSE detectors enabled simultaneous acquisition of microstructural features and elemental distribution information, with all data digitally recorded for subsequent analysis.

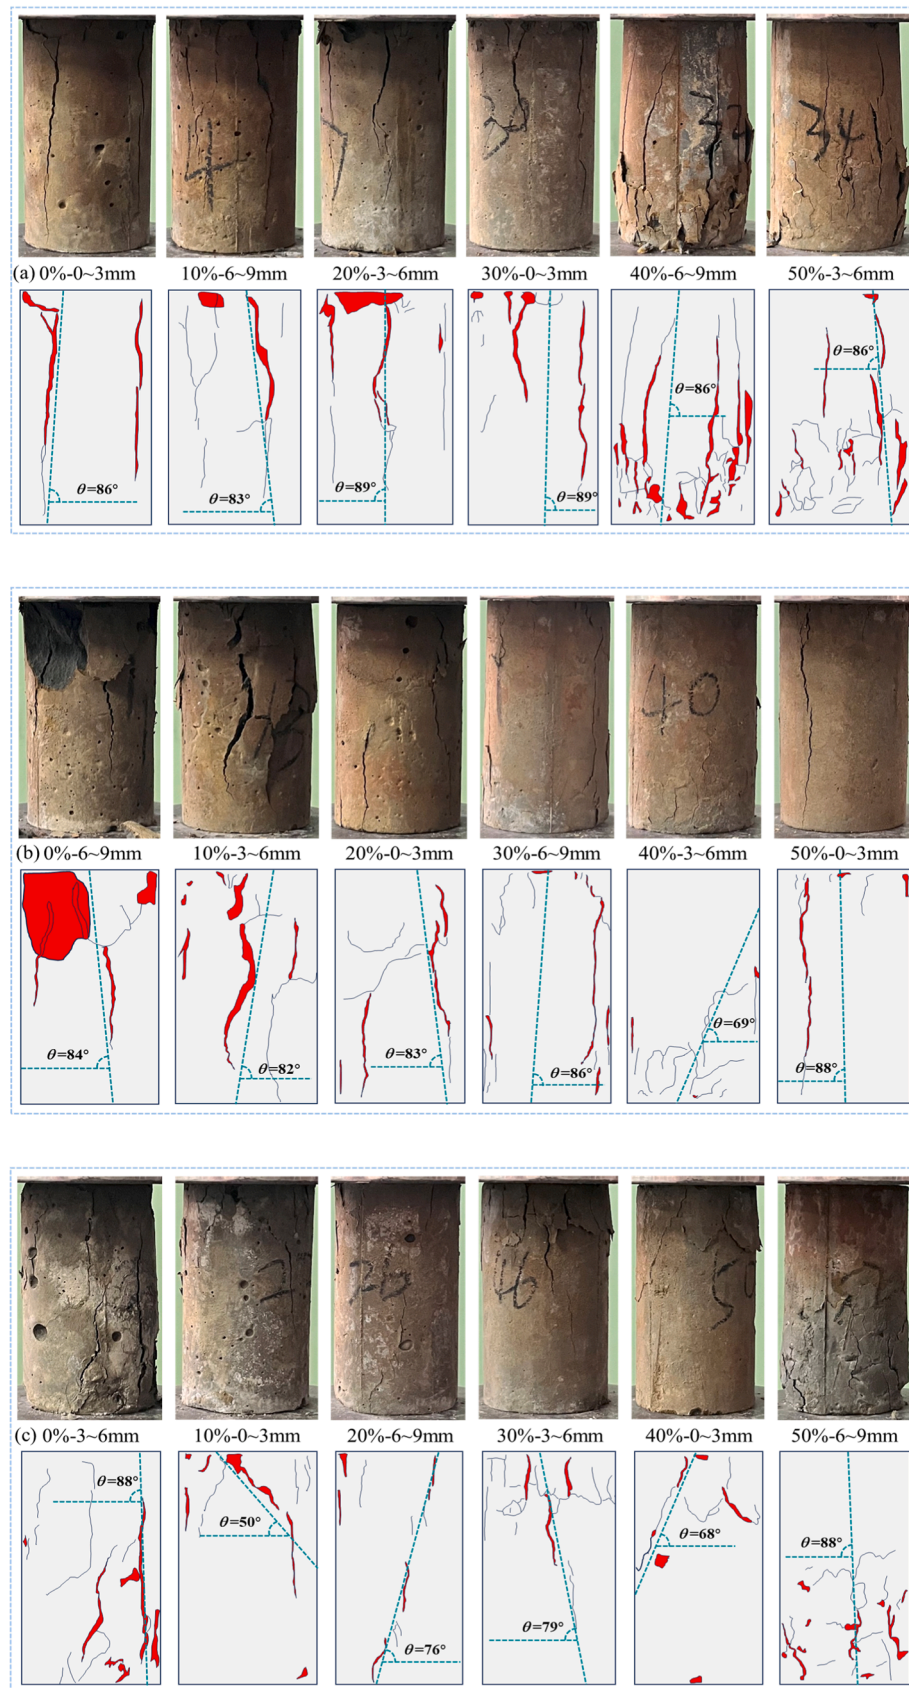
Fig. 13. Failure modes of 56-day cured specimens having a c/t ratio of (a) 1:4; (b) 1:6; and (c) 1:8.

Fig. 13(a)-(c) exhibit failing styles of CHSTCRBs cured for 56 d. For c/t proportion of 1:4, principal fracture angles ( $\theta$ ) ranged from  $83^\circ$  to  $89^\circ$ , specifically  $86^\circ$ ,  $83^\circ$ ,  $89^\circ$ ,  $86^\circ$ , and  $89^\circ$ . At c/t proportion of 1:6,  $\theta$  values varied between  $69^\circ$  and  $86^\circ$  ( $84^\circ$ ,  $82^\circ$ ,  $83^\circ$ ,  $86^\circ$ ,  $69^\circ$ , and  $88^\circ$ ). For c/t proportion of 1:8, the angles showed wider variation, ranging from  $50^\circ$  to  $88^\circ$  ( $88^\circ$ ,  $50^\circ$ ,  $76^\circ$ ,  $79^\circ$ ,  $68^\circ$ , and  $88^\circ$ ). Notably, specimens “40%–3–6 mm,” “10%–0–3 mm,” and “40%–0–3 mm” exhibited small main fracture angles of  $69^\circ$ ,  $50^\circ$ , and  $68^\circ$ . This was principally triggered by deterioration of ITZ between aggregate and matrix. Sulfate ions released from pyrite oxidation accumulated in the ITZ and formed expansive secondary minerals such as ettringite. Local expansion induced microcracks and greatly reduced the interfacial cohesion [35]. Accordingly, macroscopic failure propagated preferentially along these weakened ITZ boundaries, which accelerated shear failure.

The results revealed that CHSTCRB specimens with low rock content and coarse size predominantly failed in a brittle tensile mode, with axial cracks propagating through the entire specimen. As rock content and size augmented—for example, in fills “40%–6–9 mm” and “50%–3–6 mm”—failing style transitioned to a tensile–shear fused pattern. In these cases, axial tensile cracks appeared in the upper portion, while oblique shear cracks developed in the lower region. This behavior was

influenced by the sedimentation of crushed rock particles, which induced axial stratification: the upper layers were rich in tailings and fine particles, whereas the lower layers consisted of accumulated coarse particles. Upon complete failure, the specimens exhibited noticeable expansion and fragmentation, reflecting the complex interplay between particle distribution and mechanical response.
